**Material Testing Report**

**ISO 23907-2 Testing of Sharps Container**

**Client:** Sharpak Healthcare

**Report Number:** IMP06688-LR rev1

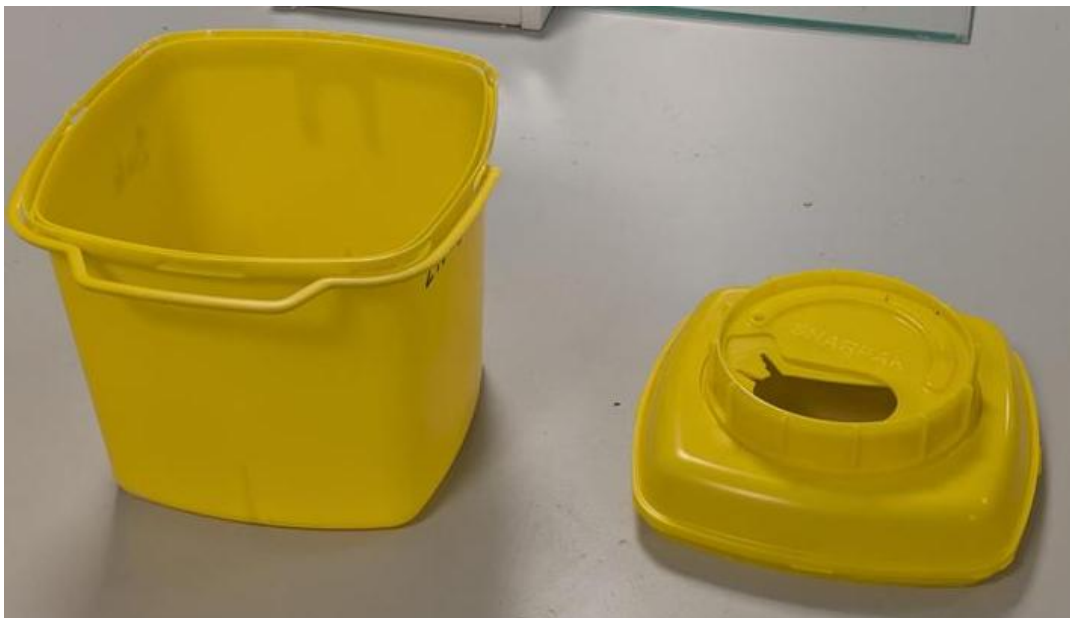
Figure 1 Example of container and lid as received
